# STORM DRAIN STUDY

## LEITHA DRIVE AND HARDY POND DRAINAGE AREA STUDY

WALTHAM, MA  
NOVEMBER 2010

Coler & Colantonio, Inc. Project # 27-38

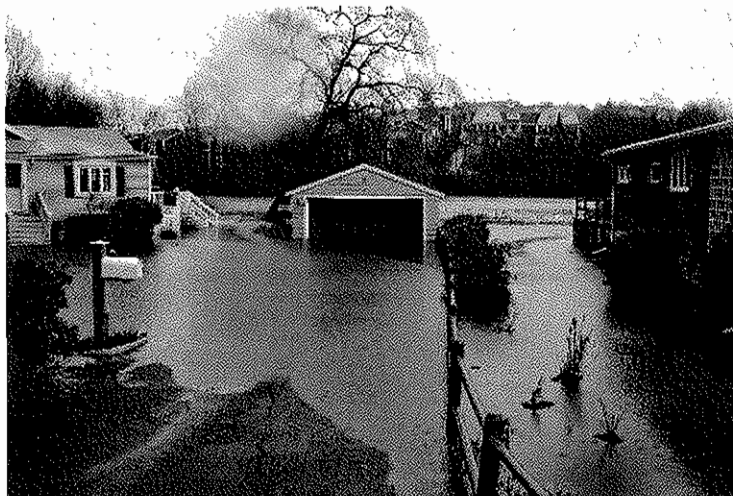
It is clear from the storm events of March 2010 that flooding is a major concern in the area of Hardy Pond (see photo 1). Site visits to inspect the Chester Brook channel downstream of Hardy pond have posed some maintenance concerns as well.

Photo 1: Flooding at a property along Hardy Pond, C&C March 2010

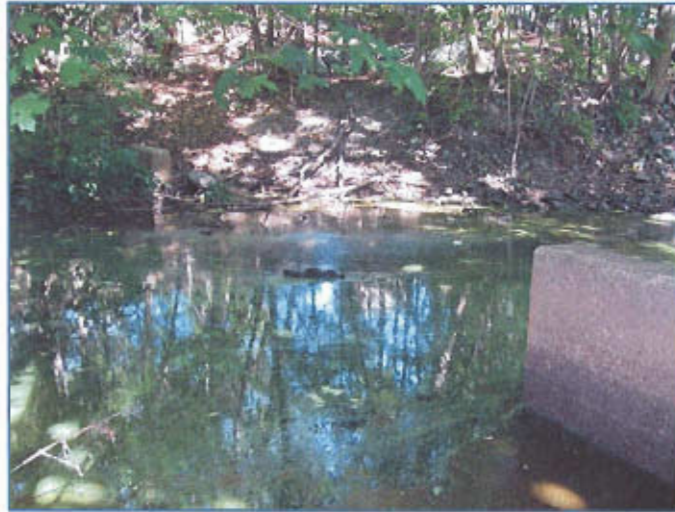
We observed that Hardy Pond discharges to Chester Brook in the northeast corner of the pond which extends easterly adjacent to the Stearns Hill Road development and heads southerly along Lexington Road and ultimately flows toward the Charles River. The easterly portion of Chester Brook was observed to have standing water with little to no flow. We encountered a concrete control structure (a rectangular weir) at the outfall from the pond to the Brook (see photo 2). Compared to known outlet elevations and water surface elevation at the time of the site visit we estimated that the weir elevation is set at an approximate elevation of 194.5'. We observed that the water surface elevation was approximately 13" above the control elevation which indicates to us that there are likely other conditions downstream that are controlling the current water surface elevation.

Photo 2: Hardy Pond Control Structure, C&C September 2010

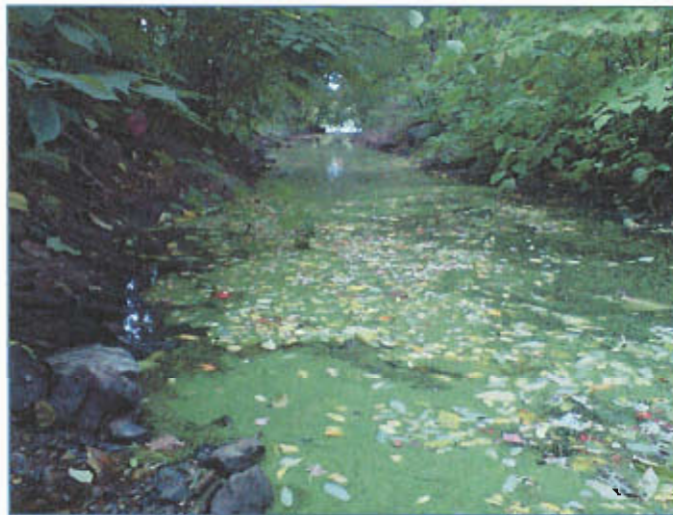
Photo 3: Stagnant Water Downstream of Control Structure, C&C September 2010

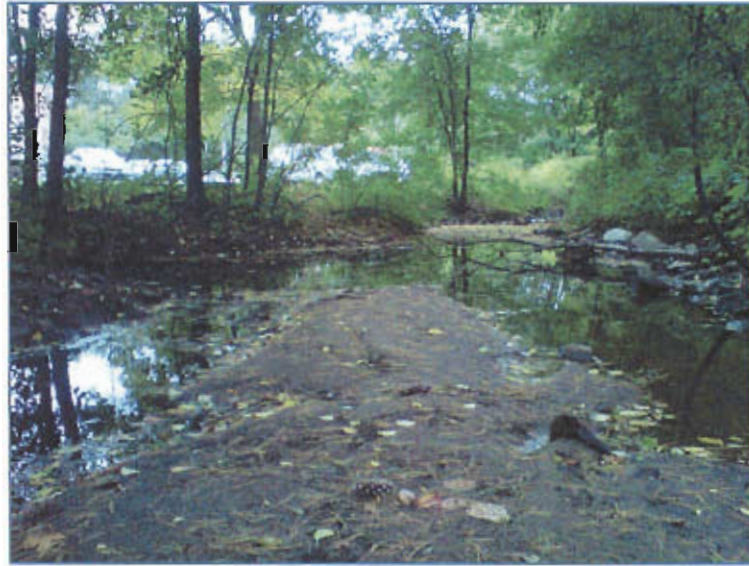
Our site walks identified that Chester Brook shows some signs of side bank erosion and sedimentation (see photo 4) in the channel that is reducing the available cross section for conveyance in low flow conditions. We also observed two areas where large stones have been placed across the channel to create walkway paths. A worn path leads to and from each crossing, indicating these paths are frequently utilized by pedestrians. These crossings have effectively created a damming effect and are restricting flow (see photo 5).

Photo 4: Sedimentation in Chester Brook, C&C September 2010

3. We recommend removal of sedimentation accumulation and obstructions within Chester Brook and restoration of the full channel cross section. This maintenance task was also recommended in the Chester Brook Master Plan (Rizzo, 2002).

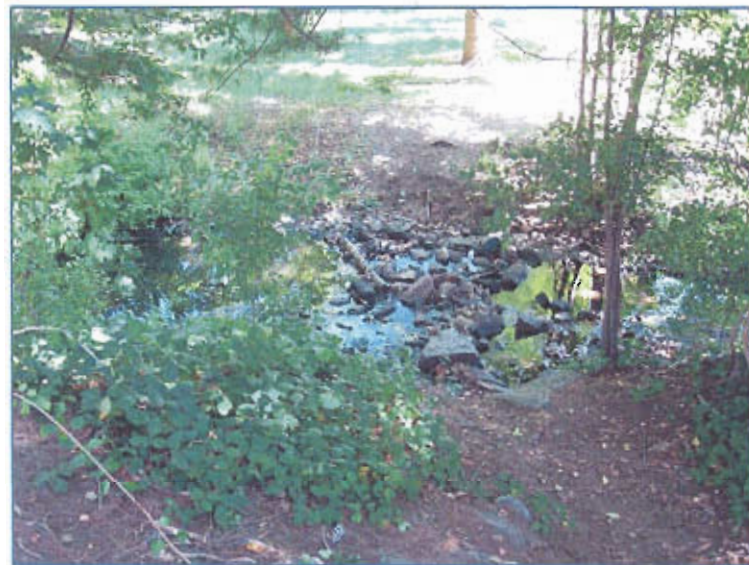
Photo 5: Improvised Stream Crossings in Chester Brook, C&C September 2010

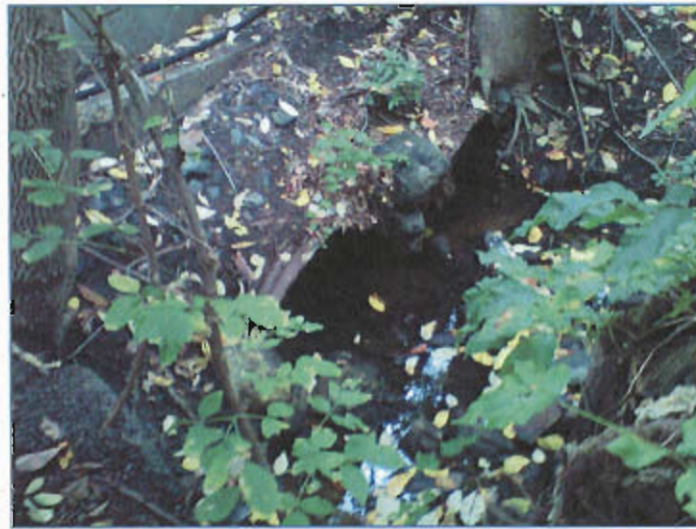
of a single 5' to 6' diameter corrugated metal culvert. Runoff in the channel appeared to pass freely through the culvert during low flow conditions. The second crossing, approximately 800' downstream is the driveway entrance to Windsor Village at Stearns Hill Road. This crossing was observed to contain two 36" corrugated metal culverts that appear to be deformed under the weight of the overlying roadway and impeded by sediment (see photo 6). Additionally, they appear to be undersized when compared to the upstream crossing and could be contributing to the restriction of flow from Hardy Pond. Site visits in March 2010 confirmed this is a major point of hydraulic constriction (see photos 7 and 8) for discharge from Hardy Pond. Repair and/or replacement of this crossing will improve the flooding of Hardy Pond. A Notice of Intent for work at this crossing was filed with the City September 24, 2010 by Thompson Farland for Windsor Property Management.

Photo 6: Stream Crossing at Stearns Hill Road, C&C September 2010

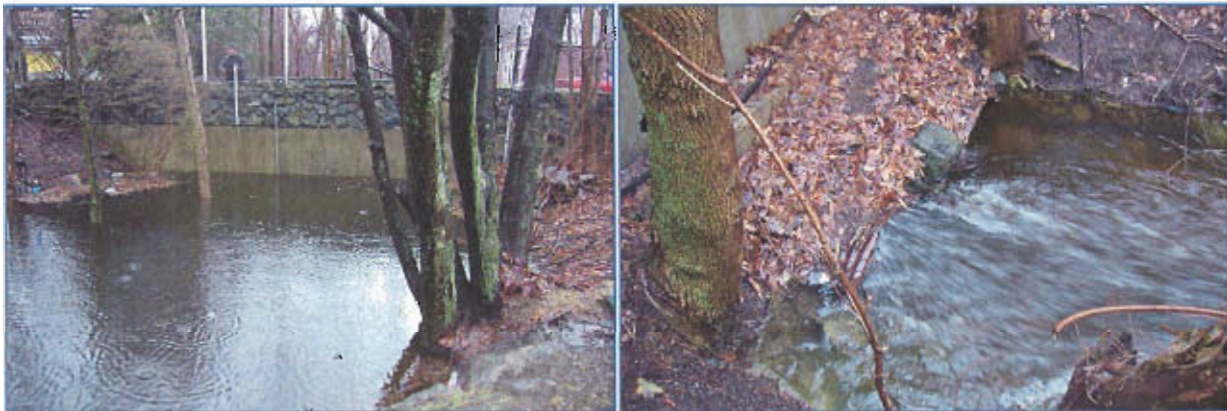
Photo 7 (Left): Upstream of Stearns Hill Road after rain event, C&C March 2010

Photo 8 (Right): Downstream of Stearns Hill Road after rain event, note that the flow seems to be stagnated in one pipe despite the fact that there is substantial head accumulated on the upstream end of the pipe, C&C March 2010

Inspections during a rain event in March of 2010, as seen in Photo 8 (p. 7), provided evidence that one of the 36" CMP culverts at Stearns Hill Road may be completely blocked or crushed. Additionally, both pipes appear to have deformed and replacement is likely the best option for improving conveyance in this area. This road is the only access point to the Windsor Village development and likely contains a great deal of the sites utilities and would have to remain open for access to and from the development. A notice of Intent submitted September 24, 2010 describes a planned upsizing and replacement of this stream crossing by Windsor Village. We feel this work is an essential component to improving the flooding in this area.

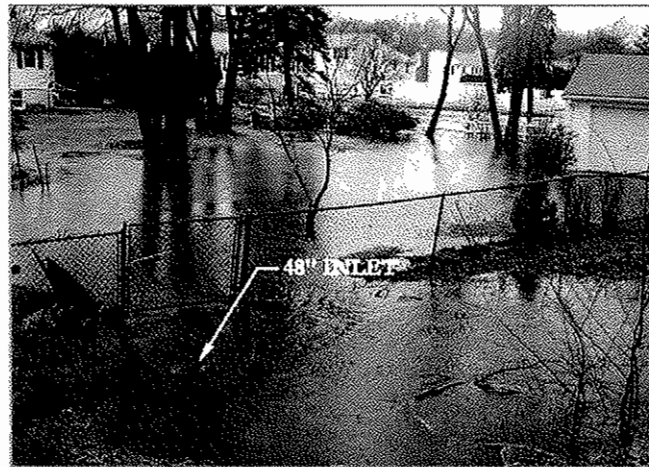
As mentioned previously, severe storms in March of 2010 have heightened the interest in addressing flooding concerns, especially in the Leitha Drive area of the Hardy Pond watershed. A swale flows to the east of Leitha Drive and conveys a large tributary area of approximately 702 acres from the north, primarily from the Town of Lexington. This flow is funneled to the Leitha Drive swale by overland flow and a channel in the Lexington wetland to the north. At the southerly end of the Leitha Drive swale flows are collected by a 48" corrugated metal pipe (see Photo 9). A small vortex is seen at the location of the pipe inlet.

Photo 9: 48" CMP at Leitha Drive swale flooding during March storms, C&C March 2010

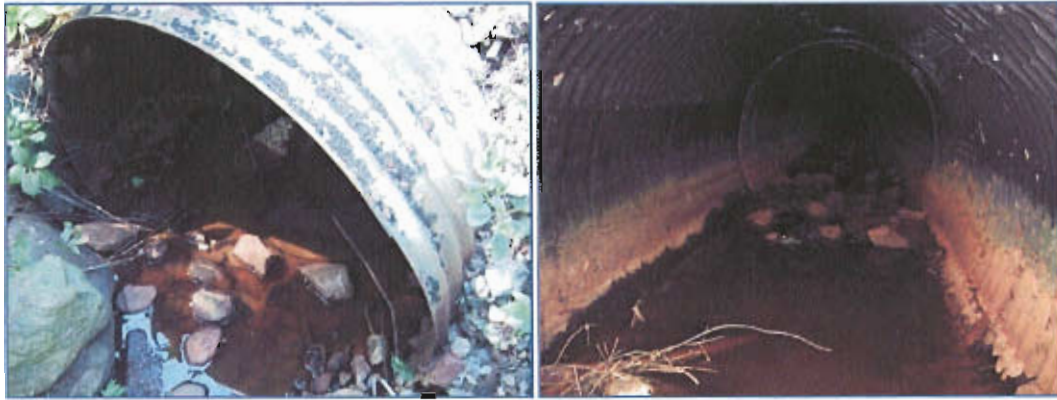
On a dry day in September of 2010 the inlet of the pipe was observed to be filled with at least 8" of debris (sand, boulders, etc.) and there is evidence of deterioration of the structure of the pipe, as seen in Photos 10 and 11 respectively. As a first measure, this pipe should be cleaned to improve conveyance from the Leitha Drive swale. After cleaning the pipe the condition can be more accurately assessed and full or partial replacement may be considered.

Photos 10 & 11: 48" Corrugated Metal Pipe inlet at Leitha Drive Swale Terminus  
C&C September 2010

1. We recommend that the City clean and inspect the existing 48" CMP conveyance pipe between the Leitha Drive swale and the 36"x42" RCP box culvert. We estimate the cost for both cleanings to be about \$3,000.
2. Visual inspections at the inlet, as seen in Photo 11 (p. 10), noted some degradation of the 48" CMP along the sediment line. Should this pipe need to be replaced after cleaning, we estimate the approximate cost to be \$55,000 for the entire 185 LF of pipe. This assumes RCP pipe and an allotment for site restoration.

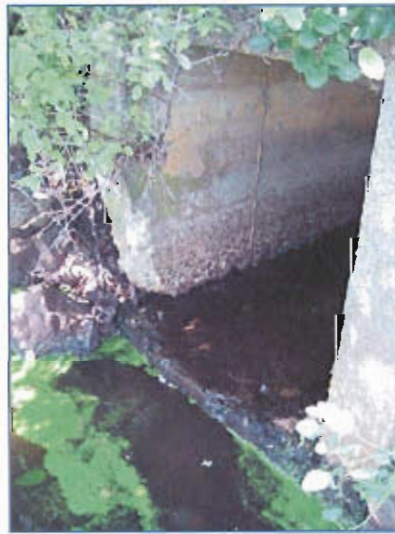
From the junction of the 48" CMP and the 36"x42" RCP box flows are conveyed approximately 750 feet at an average slope of 0.1% to the outlet at Hardy Pond (see photo 12). An additional watershed subcatchment area titled Hardy Pond C also contributes flows to Hardy Pond. Hardy Pond C is approximately 289 acres, with land uses including residential, commercial, industrial, woods and wetlands.

Photo 12: 36"x42" Reinforced Concrete Pipe outlet to Hardy Pond,  
C&C September 2010
