# STORM DRAIN STUDY

## LEITHA DRIVE AND HARDY POND DRAINAGE AREA STUDY

WALTHAM, MA  
NOVEMBER 2010

Coler & Colantonio, Inc. Project # 27-38

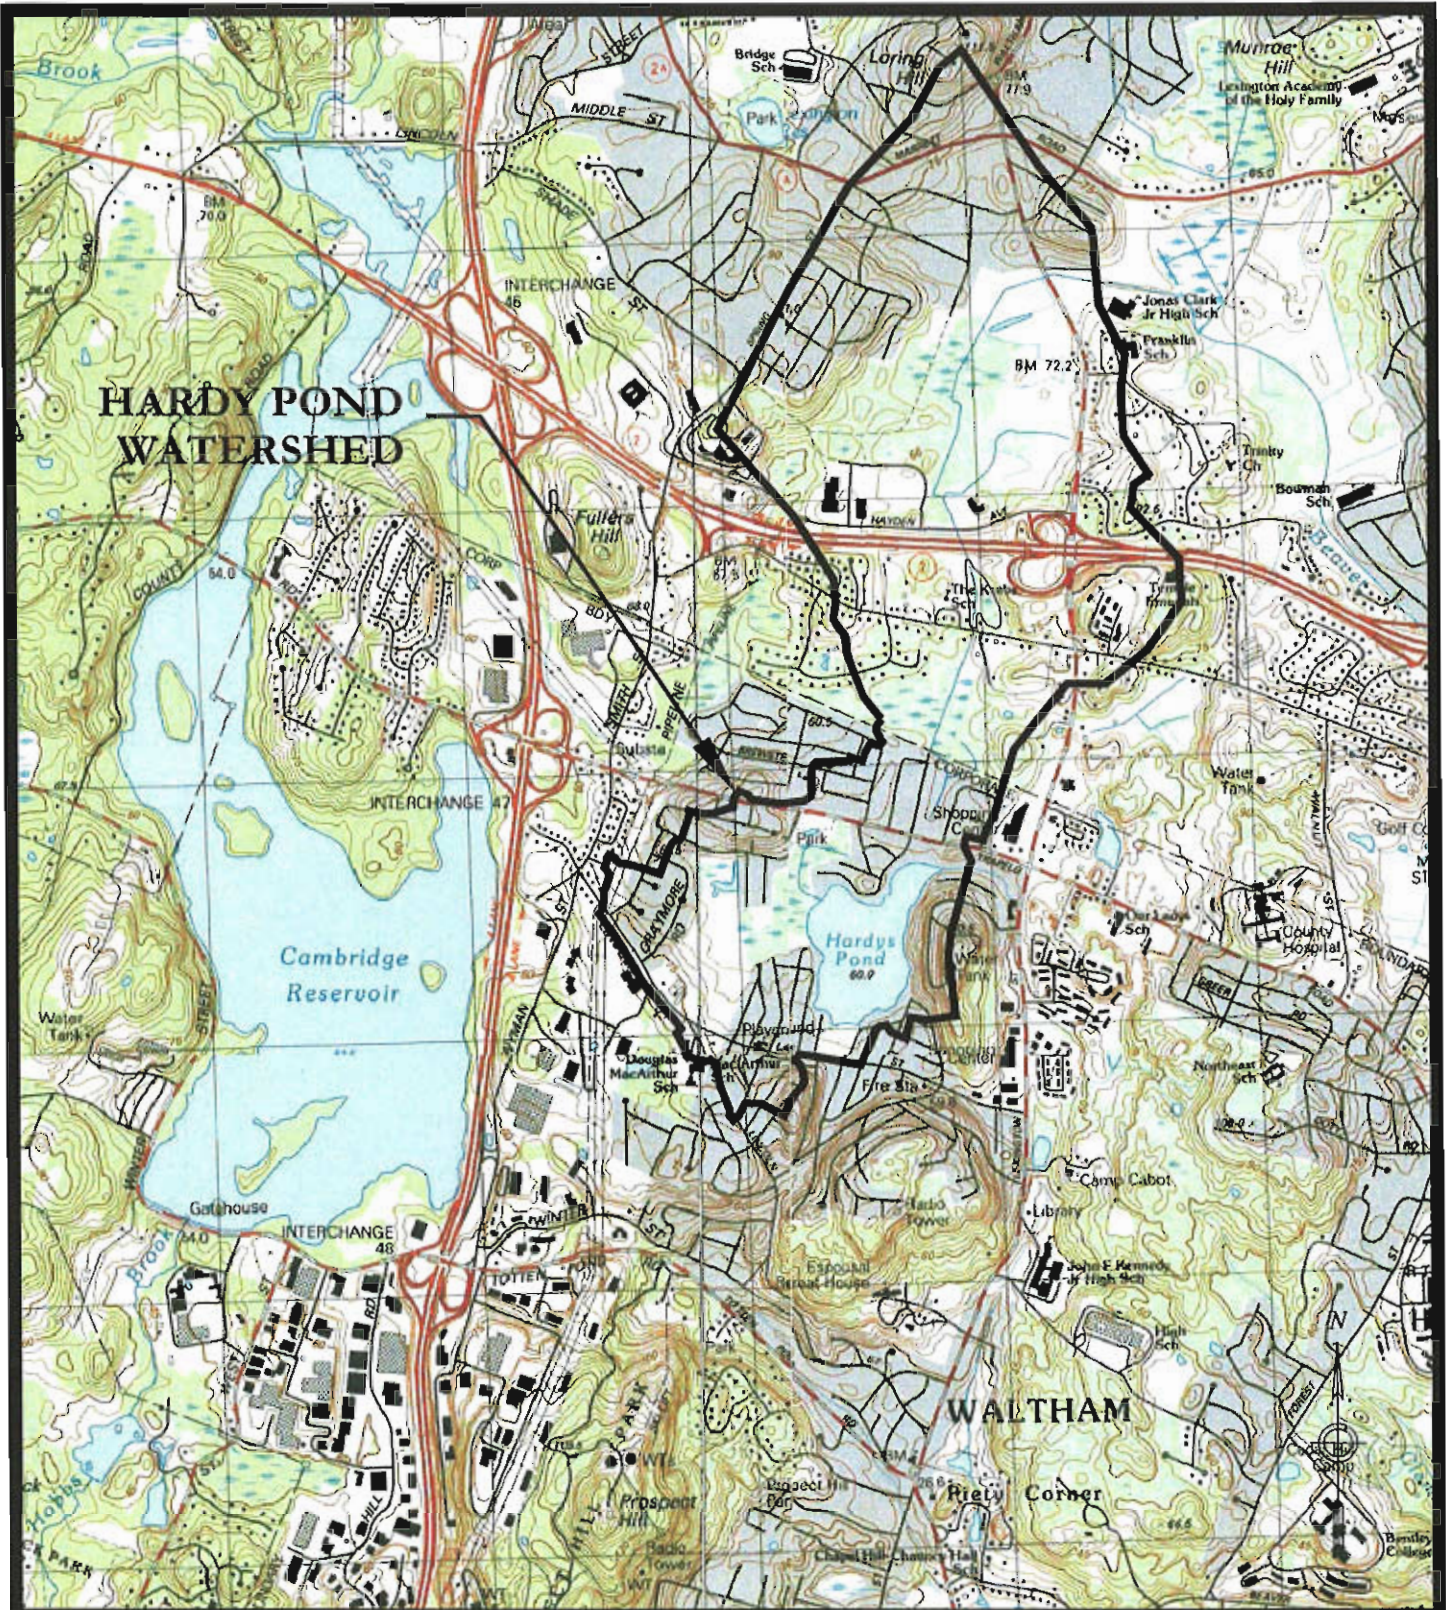
FIGURE 2: HARDY POND WATERSHED - USGS

The overall Hardy Pond watershed area is approximately 1,015 acres (see figure 2). The watershed has a variety of land uses including everything from major highways, residential, wetlands, forests, industrial, and commercial. Additionally, the watershed has soil types with characteristics covering the entire hydrologic soil group spectrum, from soils with very low infiltration rates and high runoff rates to soils with very high infiltration rates and low runoff rates. For the purpose of this study, we have divided the watershed into five subcatchment areas. Four of which are tributary to the formal drainage conveyance system downstream of the Leitha Drive swale, and the fifth comprises the rest of the drainage systems and overland flow tributary to Hardy Pond (see figure 3).

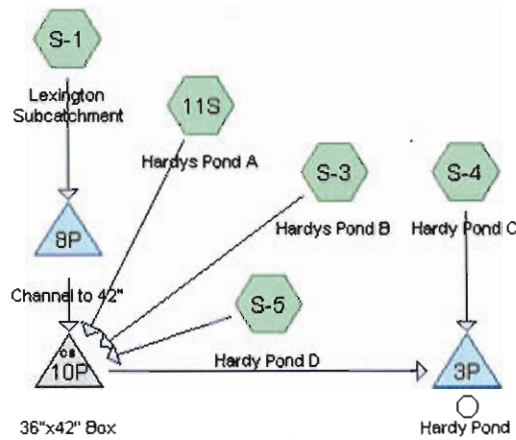
Figure 4: HydroCAD Existing Conditions

In the existing conditions model, the 48” CMP is actually modeled as a 42” to compensate for the level of sediment that is currently blocking the pipe. This blockage constricts the ability for water to leave the Leitha Drive swale. The model conveys Lexington Area flows from the Leitha Drive swale through 184 LF of 42” CMP. Hardy Pond Areas A, B, and D are added to the Lexington flows and conveyed through 744 LF of 36”x42” RCP Box culvert. At an elevation of 195.9, the Box culvert outlets into Hardy Pond. See figure 5 for a schematic.

The water surface elevation varies in the Leitha Drive Swale. This is depicted in Table 1 for each storm event. Simply cleaning the 48” CMP and effectively returning it to its full cross sectional area, reduces the accumulation of water in Leitha Drive.

1. We recommend that the City clean and inspect the existing 48" CMP conveyance pipe between the Leitha Drive swale and the 36"x42" RCP box culvert. We estimate the cost for both cleanings to be about \$3,000.
2. Visual inspections at the inlet, as seen in Photo 11 (p. 10), noted some degradation of the 48" CMP along the sediment line. Should this pipe need to be replaced after cleaning, we estimate the approximate cost to be \$55,000 for the entire 185 LF of pipe. This assumes RCP pipe and an allotment for site restoration.
